Embrittlement of a Platinum-Iridium Screen

10 January 1999

G. L. STECKEL and N. MARQUEZ
Mechanics and Materials Technology Center
Technology Operations

6. AUTHOR(S) G. L. Steckel and N. Marquez				
7. PERFORMING ORGANIZATION NAME(S) AND ADDRESS(ES) The Aerospace Corporation Technology Operations El Segundo, CA 90245-4691			8. PERFORMING ORGANIZATION REPORT NUMBER TR-99(8565)-2

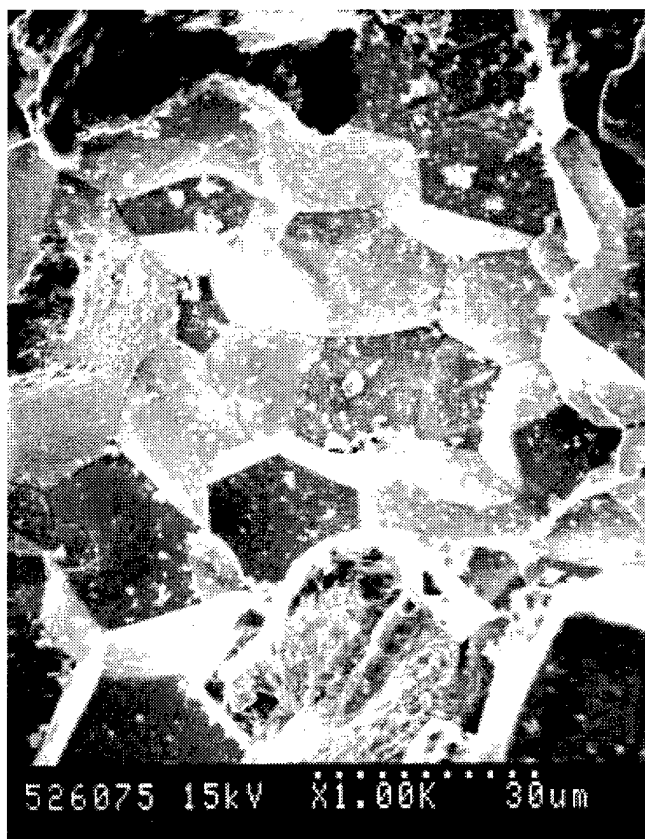
There was approximately a two-month delay between discovery of the wire fragments and the eventual disassembly of the motor discussed above. Thus, a preliminary failure analysis was performed on the wire fragments retrieved from the nozzle bag. Initially, scanning electron microscopy (SEM) utilizing energy dispersive X-rays (EDX) for chemical analyses was performed. SEM revealed the brittle intergranular nature of the fracture surfaces as shown in Figure 3. It is also apparent from

Figure 3 that the grain size of the Pt-Ir wire was unusually large. The ASTM grain size was approximately No. 7, which corresponds to an average grain diameter of 32 μm . It was also determined that the fractures consistently occurred at mesh bend points on the wires as shown in Figure 4. EDX indicated that the wire composition was approximately 88wt% Pt and 12wt% Ir. The only other element detected on the wire fractures or outer wire surfaces was aluminum. The presence of Al was attributed to catalyst particles that consist of Ir on an Al_2O_3 carrier. Catalyst particles can be seen on the fracture surface in Figure 3. No potentially embrittling contaminants were identified on the wire fracture surfaces.

Figure 3. SEM micrograph of fracture surface of Pt-Ir wire fragment. Particles on surface are from the Ir/ Al_2O_3 catalyst.

The micrograph in Figure 3 is from the SEM analysis of the wire fragments. The MMTC SEM/EDX results were completely consistent with those performed by the contractor. EDX was performed at several areas on fracture surfaces on two wire fragments such as that shown in Figure 3. In all cases, the only elements identified were Pt, Ir, Al, and O. No evidence of Si was detected. However, it should be noted that the Si K_{α} X-ray peak is located at an energy of 1.739 keV while the Pt and Ir M_{α} peaks are located at 2.048 keV and 1.977 keV, respectively. Thus, low concentrations of Si would be difficult to detect due to overlapping with the strong Pt and Ir peaks. Furthermore, EDX is not an effective technique for detection of thin layers of contaminants on material surfaces.

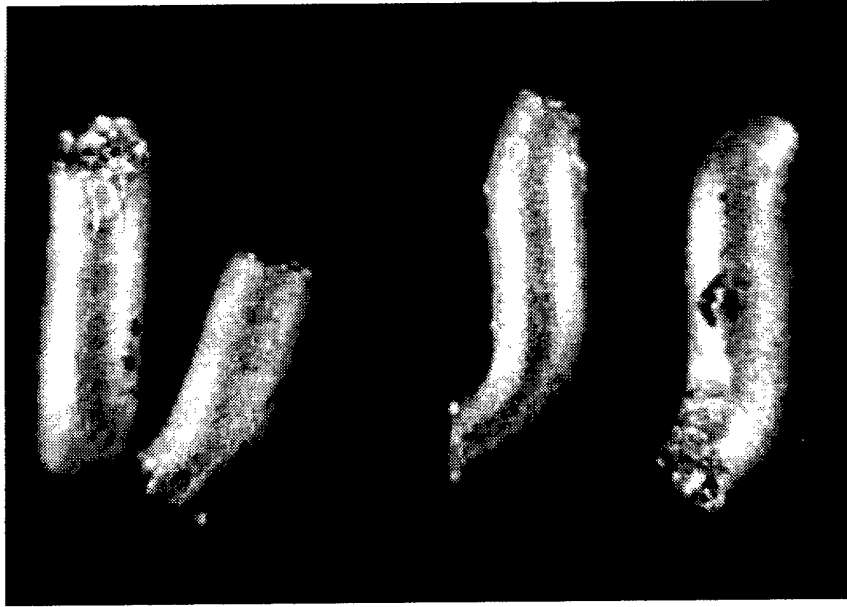
Figure 4. Photograph of four Pt-Ir wire fragments.

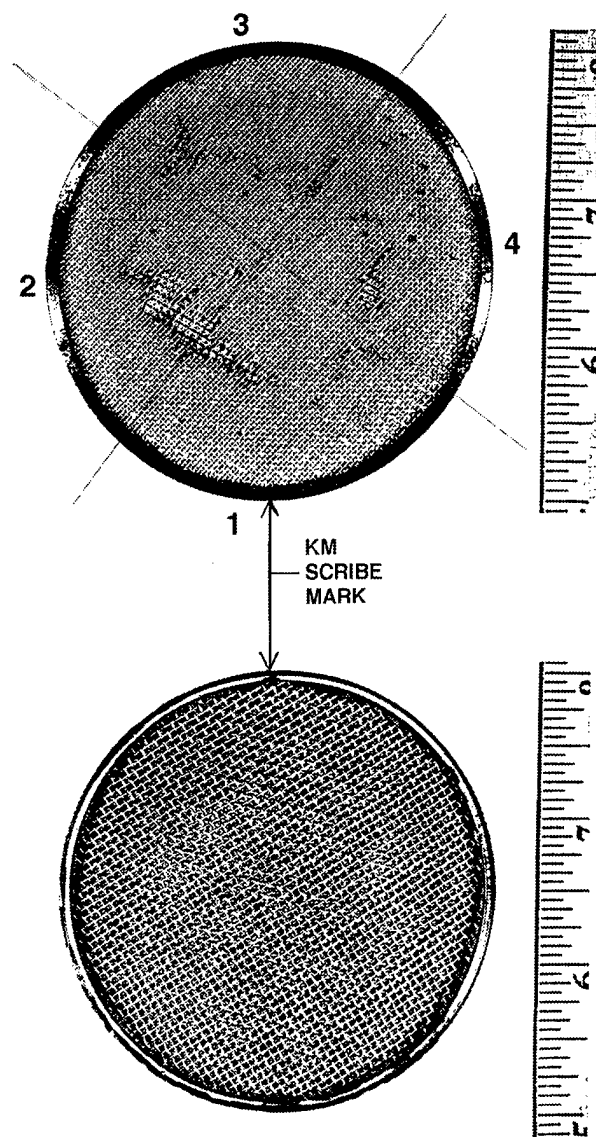
After the motor was disassembled, additional material from the mid-retainer/screen assembly was provided to MMTC for evaluation. Photographs of the front and rear surfaces of the mid-retainer/screen assembly are shown in Figure 5. The top photograph shows a circular pattern of damage to the first 40 x 40 screen due to embrittlement of the 0.010-in.-diam wires. The lower photograph shows that the 18 x 18 mesh of 0.017-in.-diam wires was undamaged. The contractor sectioned the mid-retainer/screen assembly into quadrants by cutting along the lines shown in the upper photograph and sent Quadrant No. 2 to MMTC for evaluation.

Figure 5. Photograph of up stream (top) and down stream (bottom) sides of mid-retainer/screen assembly. Top photograph shows location of cuts for sectioning into quadrants.

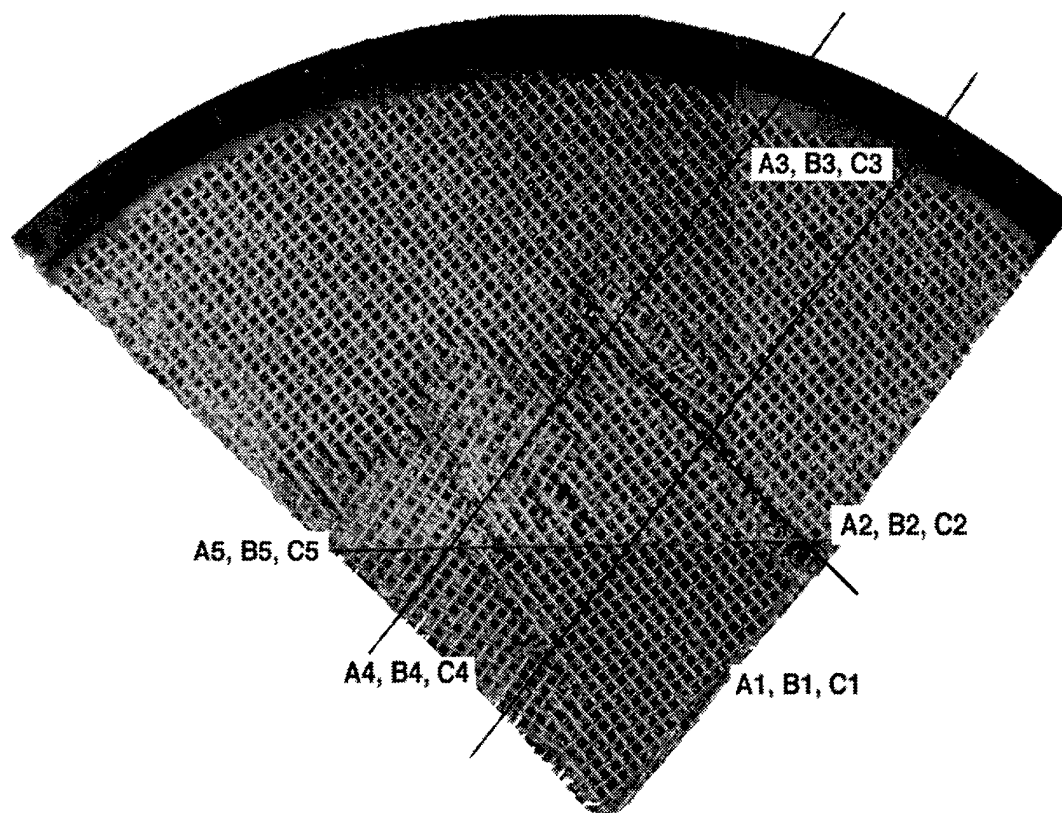
The photograph in Figure 6 shows the damaged areas on Quadrant No. 2 and the cutting pattern for removing smaller samples for various evaluations and experiments. For the purpose of convenient sample identification, the top, brittle screen was identified as Mesh A, the middle screen as Mesh B, and the lower, coarse screen as Mesh C. Initially, the entire quadrant was evaluated using SEM/EDX to document fracture features and conduct preliminary chemical analyses of the wire surfaces and fracture surfaces. The quadrant was then sectioned as shown in Figure 6 using a low-speed diamond saw with deionized water as a lubricant. Samples A1, A2, and B1 were mounted and polished for performing SIMS analyses on wire cross sections. These samples were selected to allow comparisons between areas on Mesh A with and without brittle failures (A1 and A2, respectively) and to compare the damaged Mesh A with the apparently undamaged Mesh B. Samples A3, B3, and C3 were used for SIMS analyses of the wire surfaces. The intent of these analyses was not only to compare the surface chemistry for the three screens, but to also make comparisons between the "high points" (tensile side) of the wires at crossovers in the weave to the "saddle points" (compressive side) where the crossing wires contact one another. The high points can easily be contaminated during handling of the screens, whereas the saddle points are somewhat protected from contamination.

Figure 6. Photograph of Quadrant No. 2 from Mid-Retainer/Screen Assembly. The Screens Were Sectioned into Samples and Identified as Shown. Mesh A = Top, Embrittled Screen, Mesh B = Middle Screen, and Mesh C = Bottom Screen.

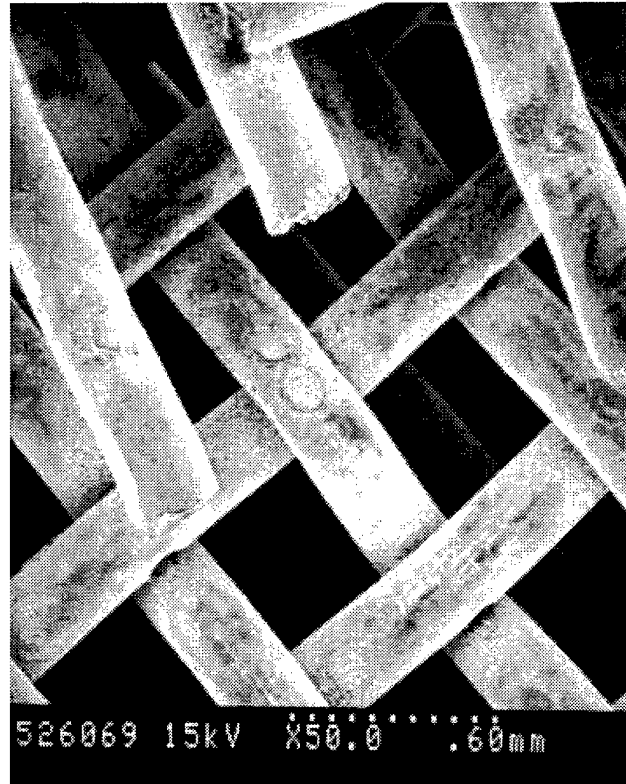
Extensive SEM/EDX analyses were conducted on the damaged areas of Quadrant No. 2. The primary objective of these analyses was to look for the presence of any contaminants that could have led to the embrittlement of Mesh A. Figure 8 shows a typical area from the damaged region. This figure shows four wires having brittle fractures, three wires oriented in one weave direction and one wire oriented in the other weave direction. Thus, the embrittlement did not appear to be associated with any preferential wire orientation within the screen. The Mesh B and Mesh C wires can be seen below the fractured Mesh A wires in the figure. The wires for all three screens had rough surfaces due to a high density of catalyst particles. EDX analyses at numerous locations on the wire surfaces revealed only Pt and Ir from the wires and Al, O, and Ir from the catalyst. A higher-magnification view of a cracked wire (Figure 9) shows the particles on the surface. This micrograph is typical of many cracked wires and shows the brittle, intergranular nature of the cracks. EDX analyses were also performed on the clean faces of these cracks just below the wire surface. These analyses usually revealed only Pt and Ir. Occasionally, Al and O were also detected, presumably from catalyst particles falling into the crevices.

Figure 8. SEM micrograph of damaged area on mid-retainer/screen assembly.

Figure 8 also shows that the wires underwent considerable deformation at the crossover points of the weave. The wire in the upper right corner of the figure appears to be slightly kinked within the saddle point of the crossover. This was a common observation. Figure 10a shows a higher magnification of a kinked saddle point. The saddle points were characterized by a reduced density of catalyst particles and considerable etching of the grain boundaries. Thermal etching of grain boundaries commonly occurs during high-temperature vacuum annealing (brazing operation), but may also occur in high-temperature reducing environments (motor firing). A higher-magnification view in Figure 10b demonstrates that in some areas, grains were completely dislodged. Other saddle points showed complete dissolution of the grain boundaries (Figure 11a), the development of voids at the grain boundaries (Figure 11b), or possible surface melting (Figure 11b). These observations are probably indicative of the embrittlement process and are contributors to the apparent partial fusion between crossing wires.

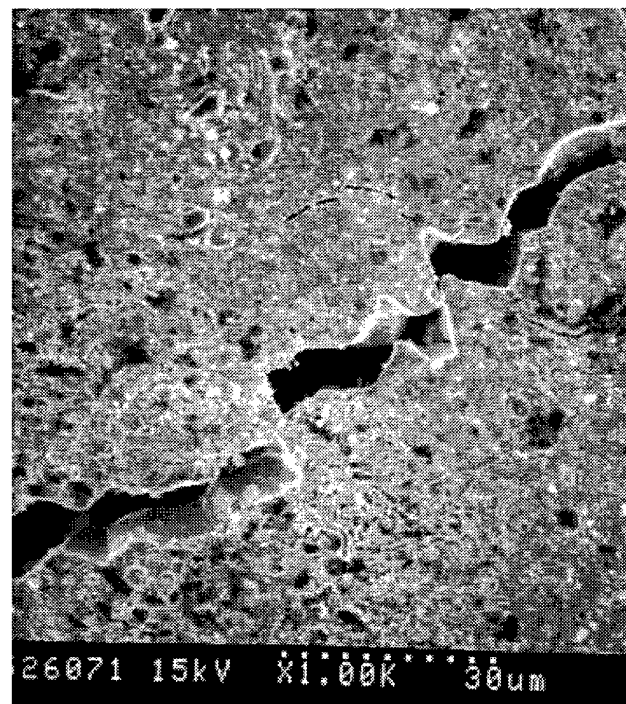
Figure 9. SEM micrograph of cracked Pt-Ir wire on Mesh A.

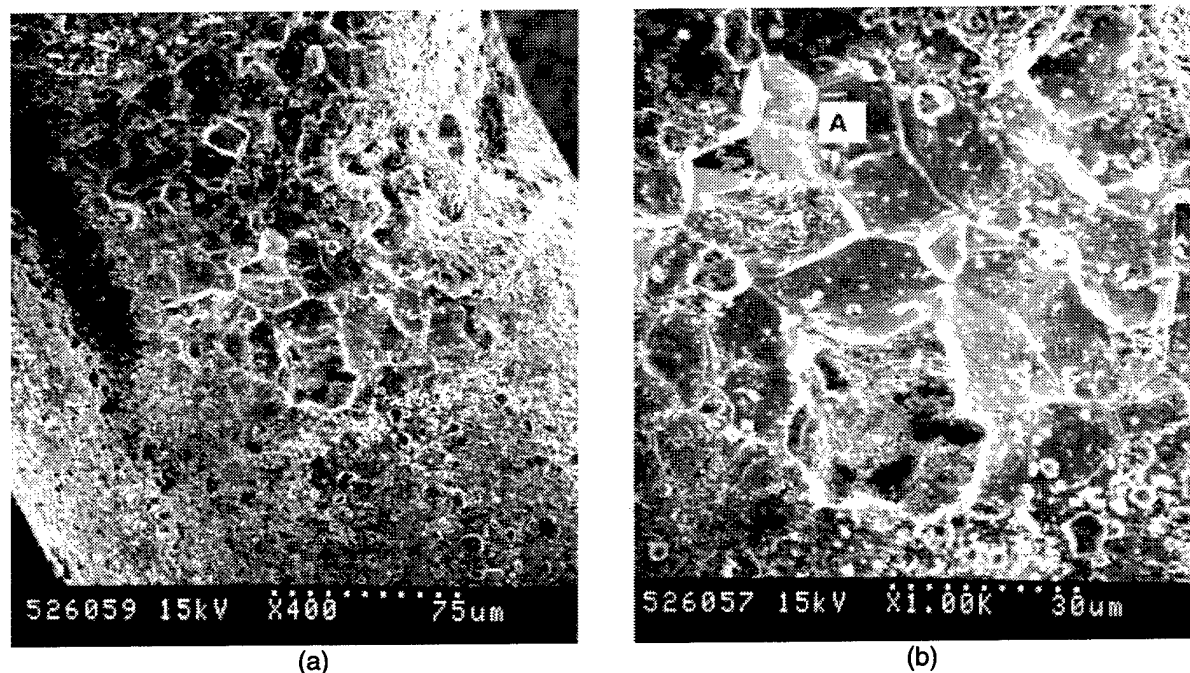
The saddle points shown in Figures 10 and 11 are from areas on Mesh A in which the saddle points were exposed when the crossing wire fractured. In order to view the saddle points on Meshes B and C, it was necessary to extract the crossing wire. Figure 12 shows a saddle point on Mesh C, which has the appearance of a ductile fracture surface. This fracture surface is direct evidence that the crossing wires were fused together. Figure 12 is typical of all saddle points (4 or 5) examined in the SEM for Mesh C. A larger number of saddle points was examined on Mesh B. Most of the Mesh B saddle points had the ductile fracture surface characteristic of the separation of fused wires over part of the crossover area and the "free surface" features shown in Figures 10 and 11 over the remainder of the area.

Figure 10. SEM micrographs of a saddle point of a crossover point on Mesh A. The higher-magnification micrograph (b) shows dislodged grains at point A.

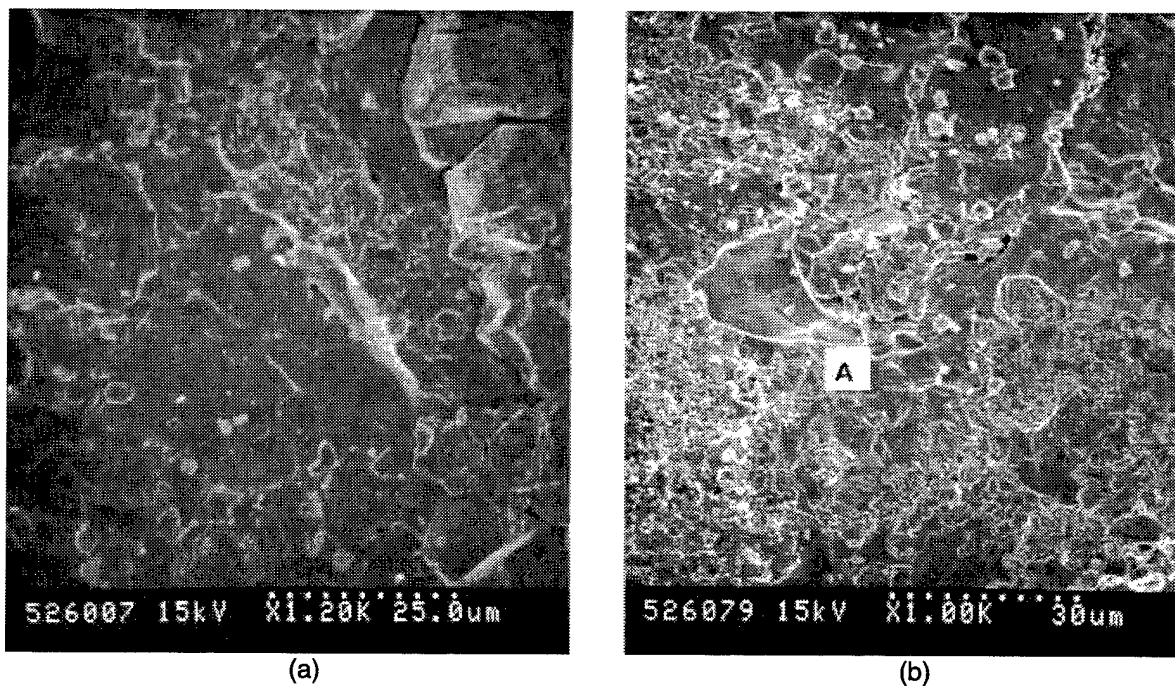
Figure 11. SEM micrographs of two saddle points at crossover points on Mesh A. Extensive grain boundary dissolution is shown in (a). Grain boundary voids along with possible melting at location A are shown in (b).

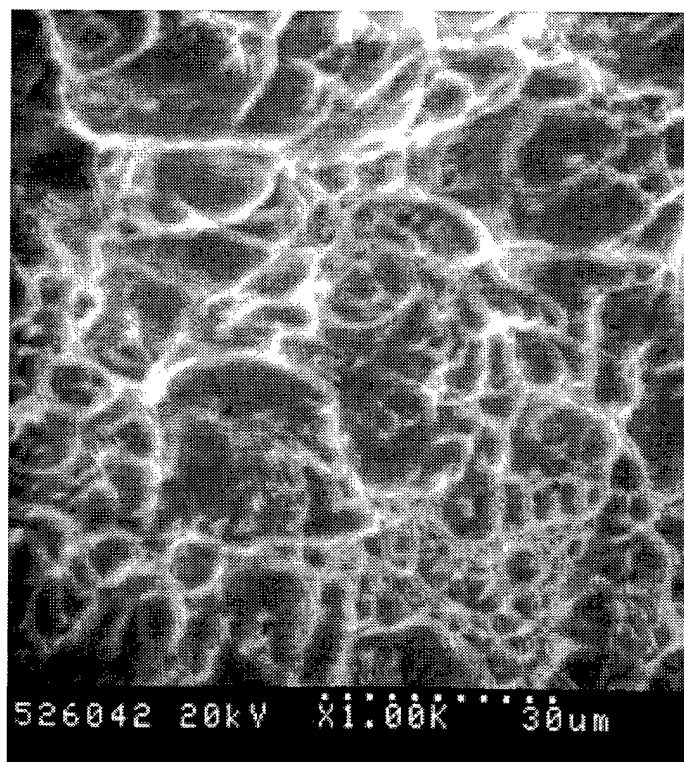
Figure 12. SEM micrograph of a saddle point of a crossover point on Mesh C.

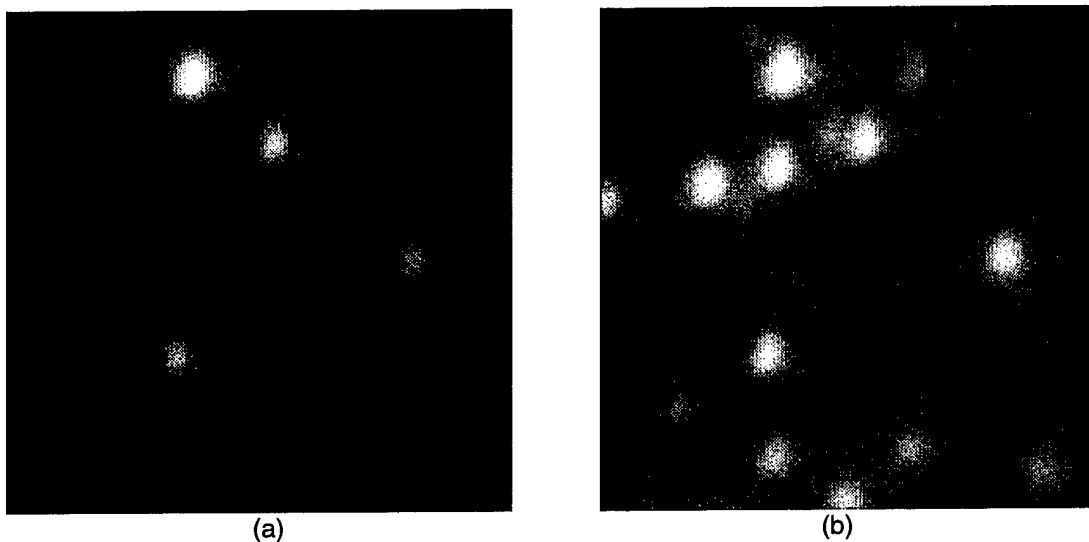
counts is indicated in parentheses for each element or compound. Spectral data are presented for two separate areas on Sample Nos. A1 and A2, and for one area on all other samples. Similar elemental spectra were obtained for the wire fragment, the two areas on Sample Nos. A1 and A2, and the one area on Sample No. B1. The primary impurities were Cr, Rh, Al, In, Si, and Ca. Rh was not included in Table 2 or Figure 13 since the presence of Rh is expected and is of no concern. Indium was the most surprising impurity and appeared to be present in significant levels, although not at concentrations sufficient to be detected by SEM/EDX. Cr, Rh, Si, and Ca were all detected in the bulk chemical analysis (Table 1), while Al was not detected, and In was not checked for in the bulk analysis. Elemental mapping indicated that the Cr, Rh, Al, and In were distributed uniformly throughout the cross section. The Ca and Si were associated with one another and appeared to be present as distinct particles, as shown by the elemental maps in Figure 14 for Sample No. A2, Area B.

Figure 14. Silicon (a) and calcium (b) Maps of analysis Area B on cross section of Sample No. A2. Bright spots indicate presence of Si or Ca.

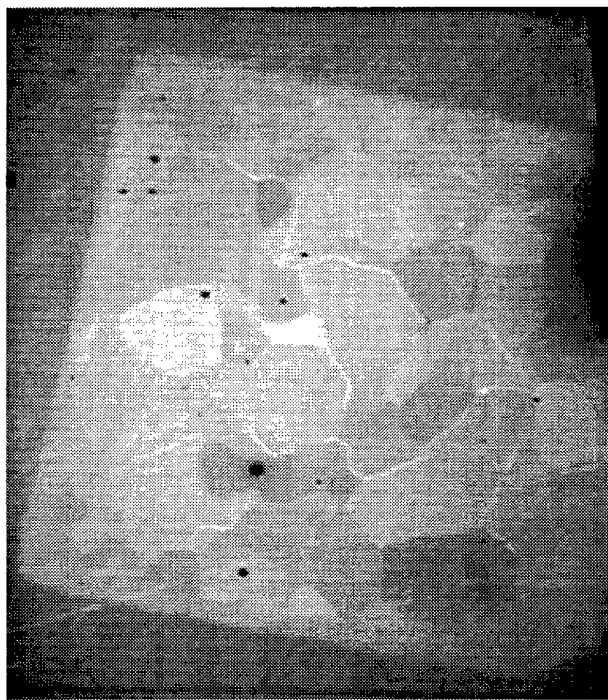
Initially, there was some concern that the Si- and Ca-rich particles might be contamination from the SiC abrasive paper used in the sample grinding operation. However, additional mapping indicated that there was no carbon associated with the particles. Furthermore, it was discovered that during depth profiling, some of the particles were sputtered away while new particles appeared at different points. Thus, it was concluded that the particles were present within the bulk of the samples and were not a sample preparation artifact. The relative spatial positioning of the particles, as demonstrated by the Ca map in Figure 14, suggested that the particles could be located at the grain boundaries. Unfortunately, the magnification (70x) of the optical microscope on the microprobe was not adequate to sufficiently resolve the grain structure to make any correlation between the relative locations of the grain boundaries and the Ca-Si particles. However, the ion beam does etch the sample over the 100- μ m analysis area. Therefore, the analysis area could subsequently be identified with the SEM and is shown in Figure 15. EDX analyses indicated that most of the dark spots in Figure 15 are composed of Ca, Si, and O. The other dark spots appear to be voids left behind by dislodged particles. These particles are assumed to be the same as shown in Figure 14, and some correlation in the location of the particles can be seen when comparing the two figures. The most significant observation from Figure 15 is that most of the Ca-Si-O particles are located within the grains rather than at the grain boundaries. For this reason, it was concluded that these particles probably did not cause the embrittlement of Mesh A. This conclusion was further supported by the fact that the particles were not only observed by SIMS mapping on all Mesh A samples, but were also present on Mesh B (Sample B2), which showed no evidence of embrittlement.

Figure 15. SEM Micrograph of Area B on Sample No. A2 following SIMS analysis. EDX analysis indicated that dark spots are Ca-Si-O particles.

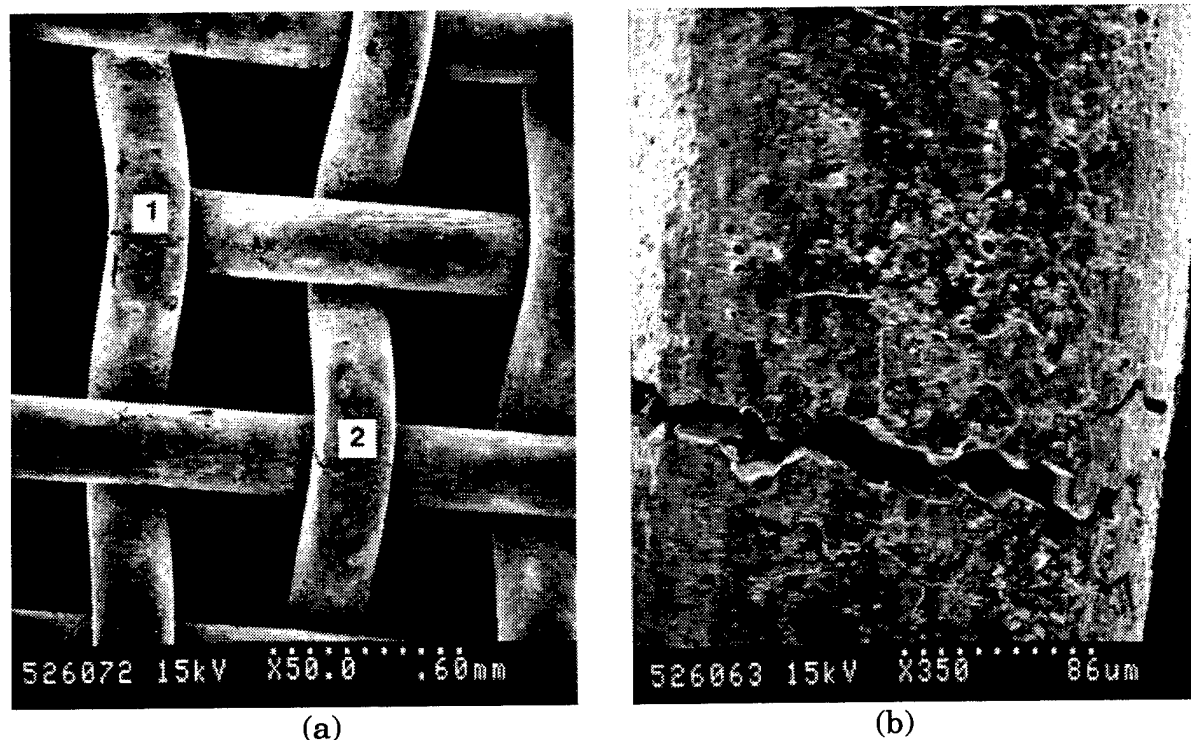
Sample Nos. A3, B3, and C3 were examined in the SEM following the SIMS analyses. Figure 18a shows Areas 1 and 2 from the SIMS analyses on Sample No. A3, and Figure 18b shows a higher-magnification view of Area 2. A comparison of Figure 18b with Figure 9 shows that the 90-min ion sputtering during the SIMS analysis cleaned a significant fraction of the catalyst particles from the wire surface and also etched the grain boundaries. Extensive EDX over the etched area did not reveal any elements other than Pt, Ir, Al, and O. Thus, although the Mn/Pt and Ga/Pt secondary-ion count ratios after sputtering were very high on Area 2 (Figure 16), the actual concentrations of Ga and Mn were too low to be detected by EDX.

Figure 18. SEM micrographs of Sample No. A3 following SIMS analysis. Micrograph (a) shows Areas 1 & 2 adjacent to cracks. Micrograph (b) is higher-magnification view of Area 2.

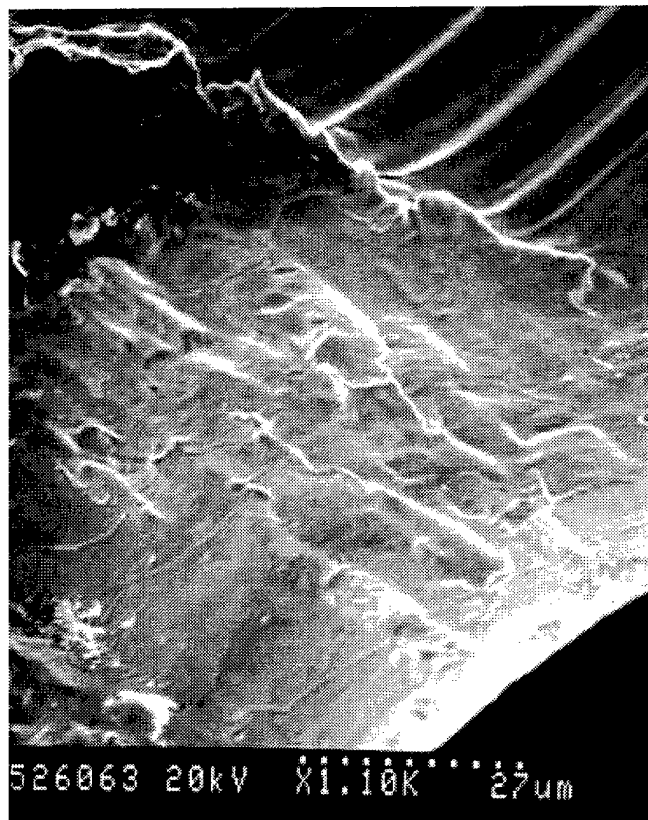
The Kaiser Marquardt Pt-Ir screens designated Lot Nos. 1 and 2 that were subjected to the braze simulation heat treatment were submitted to MMTTC for evaluation. The primary goal was to determine whether these screens exhibited the partial fusion at weave crossover points that were observed for the screens from REM S/N KM004. Lot No. 1 was heat treated at 1150°C (2100°F) for 2 h to simulate the braze operation. Lot No. 2 was subjected to this heat treatment twice. Wires were extracted from both screens under a stereo microscope at a magnification of 20x. For both heat-treated lots, the wires were very easily extracted with no indications of fusion between wires. Figure 19 shows that the wires were subjected to substantial deformation at the crossover points, not unlike the deformation experienced by the wires in the S/N KM004 screens. However, the wires in the Lot No. 1 and 2 screens showed no evidence of the dislodged grains, dissolution of grain boundaries, voids at the grain boundaries, or fusion between wires seen on the embrittled wires.

Figure 19. SEM micrograph of a saddle point of a crossover point on Kaiser Marquardt Lot No. 2 screen following heat treatment simulating brazing.
